Medical Imaging of Vertebral Compression Fractures

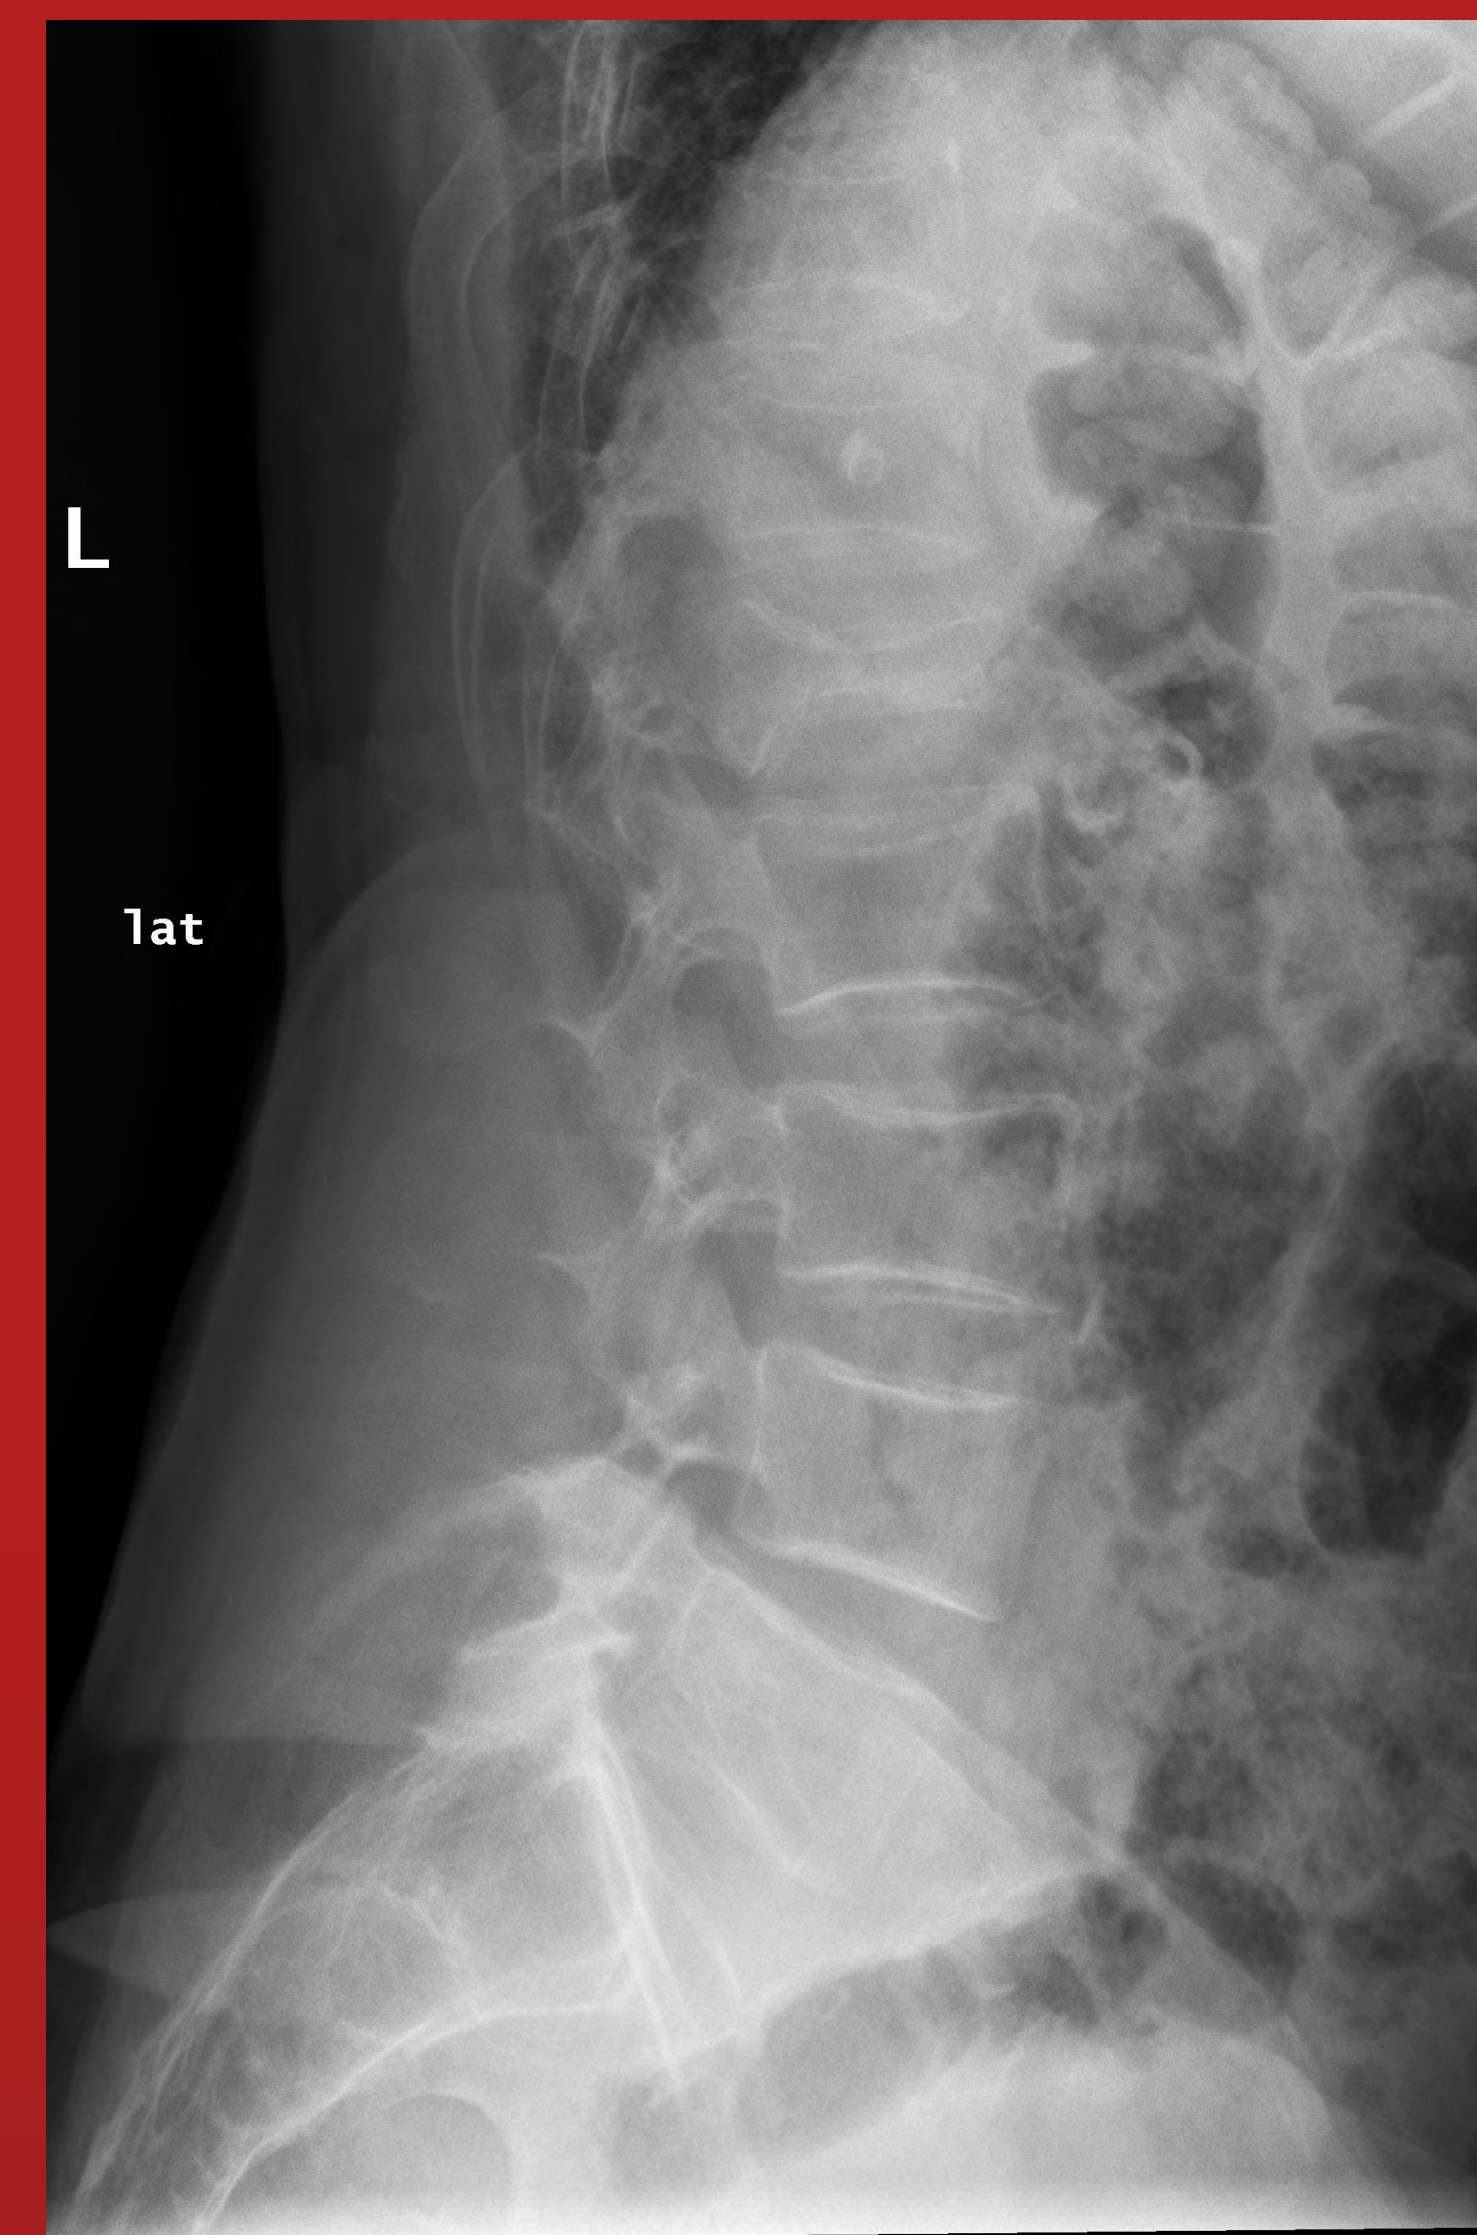
Figure 1. Lateral radiographic projection of lumbar spine demonstrating a compression fracture at L1. Significant loss of vertebral height is shown. Retrieved from facility PACS system.

Radiography is often the first modality of choice employed by physicians for the initial assessment of a patient's spine (see figure 1). The lateral projection provides the most diagnostic information for radiologists when assessing a compression fracture (Colangelo, 2014; Dewar, 2015; Odle, 2017).

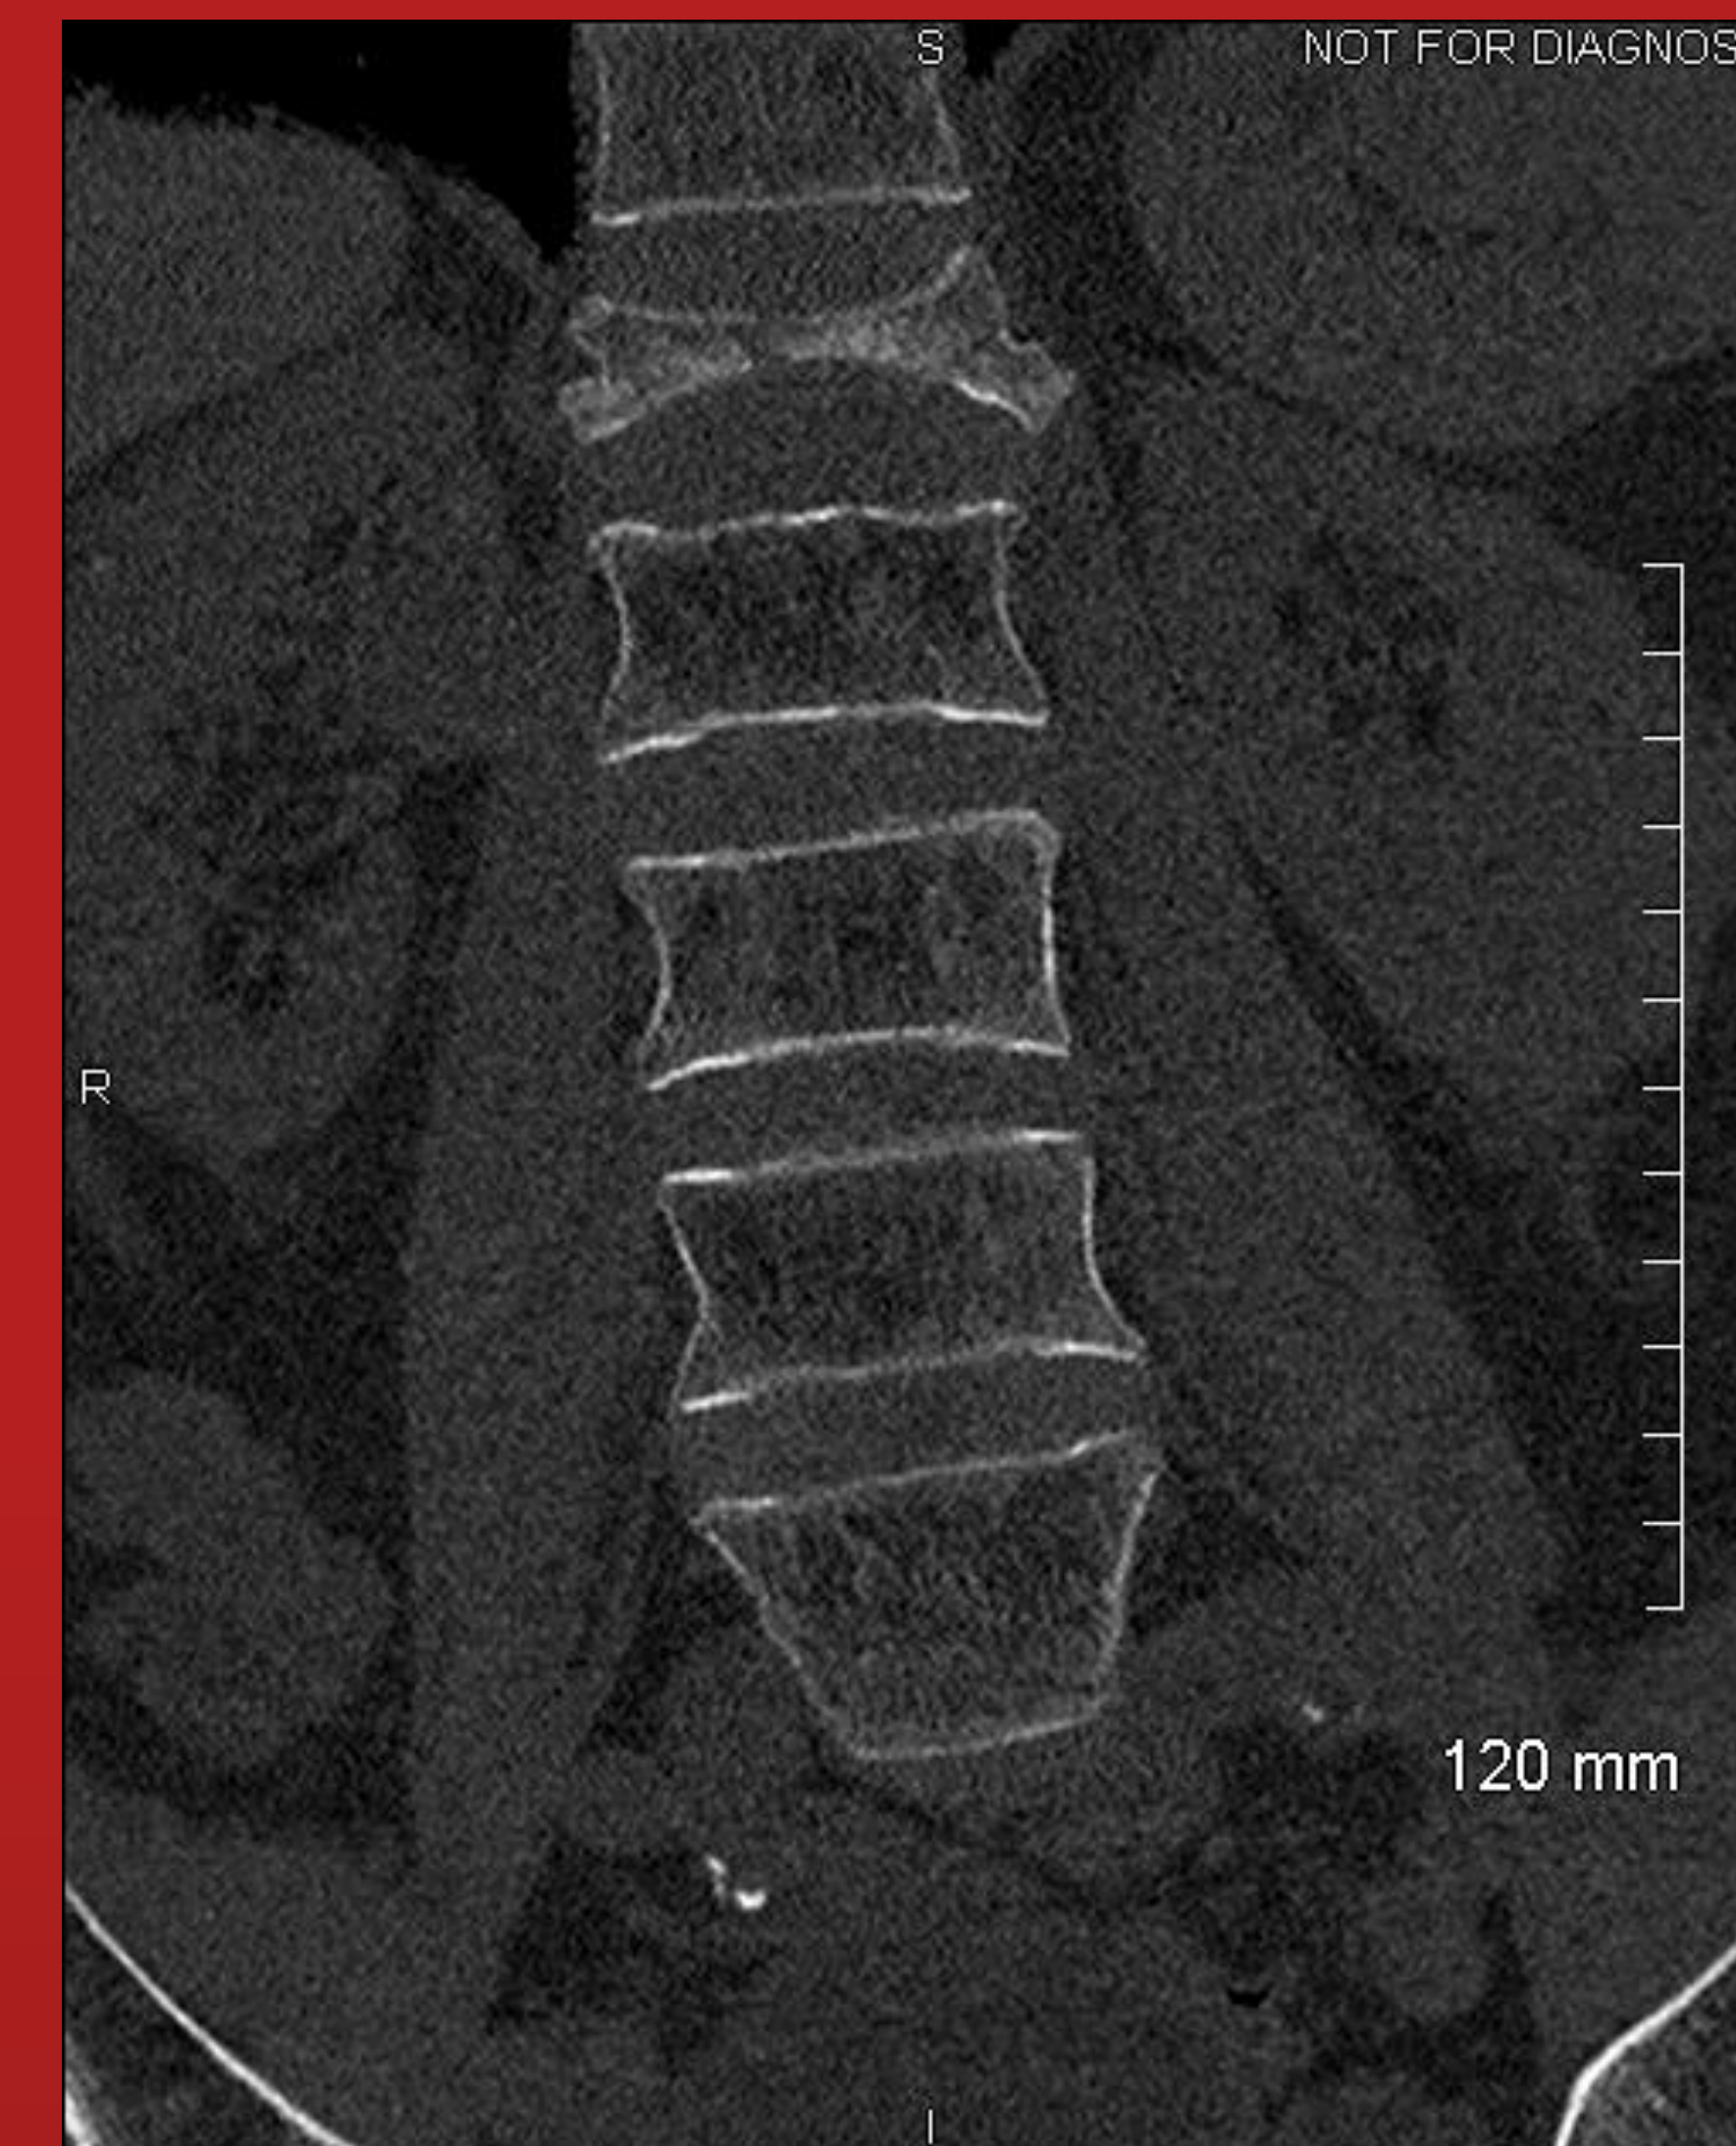
Figure 2. Coronal CT image demonstrating a compression fracture at L1. Significant loss of vertebral height is again displayed along with fragmentation of the vertebra near midline and along the left edge. Retrieved from facility PACS system.

Computed tomography (CT) is often utilized to better visualize bony anatomy (see figure 2). CT can provide much greater detail and analysis of a compression fracture's loss of vertebral height as well as the localization of fracture fragments (Colangelo, 2014; Dewar, 2015; Odle, 2017).

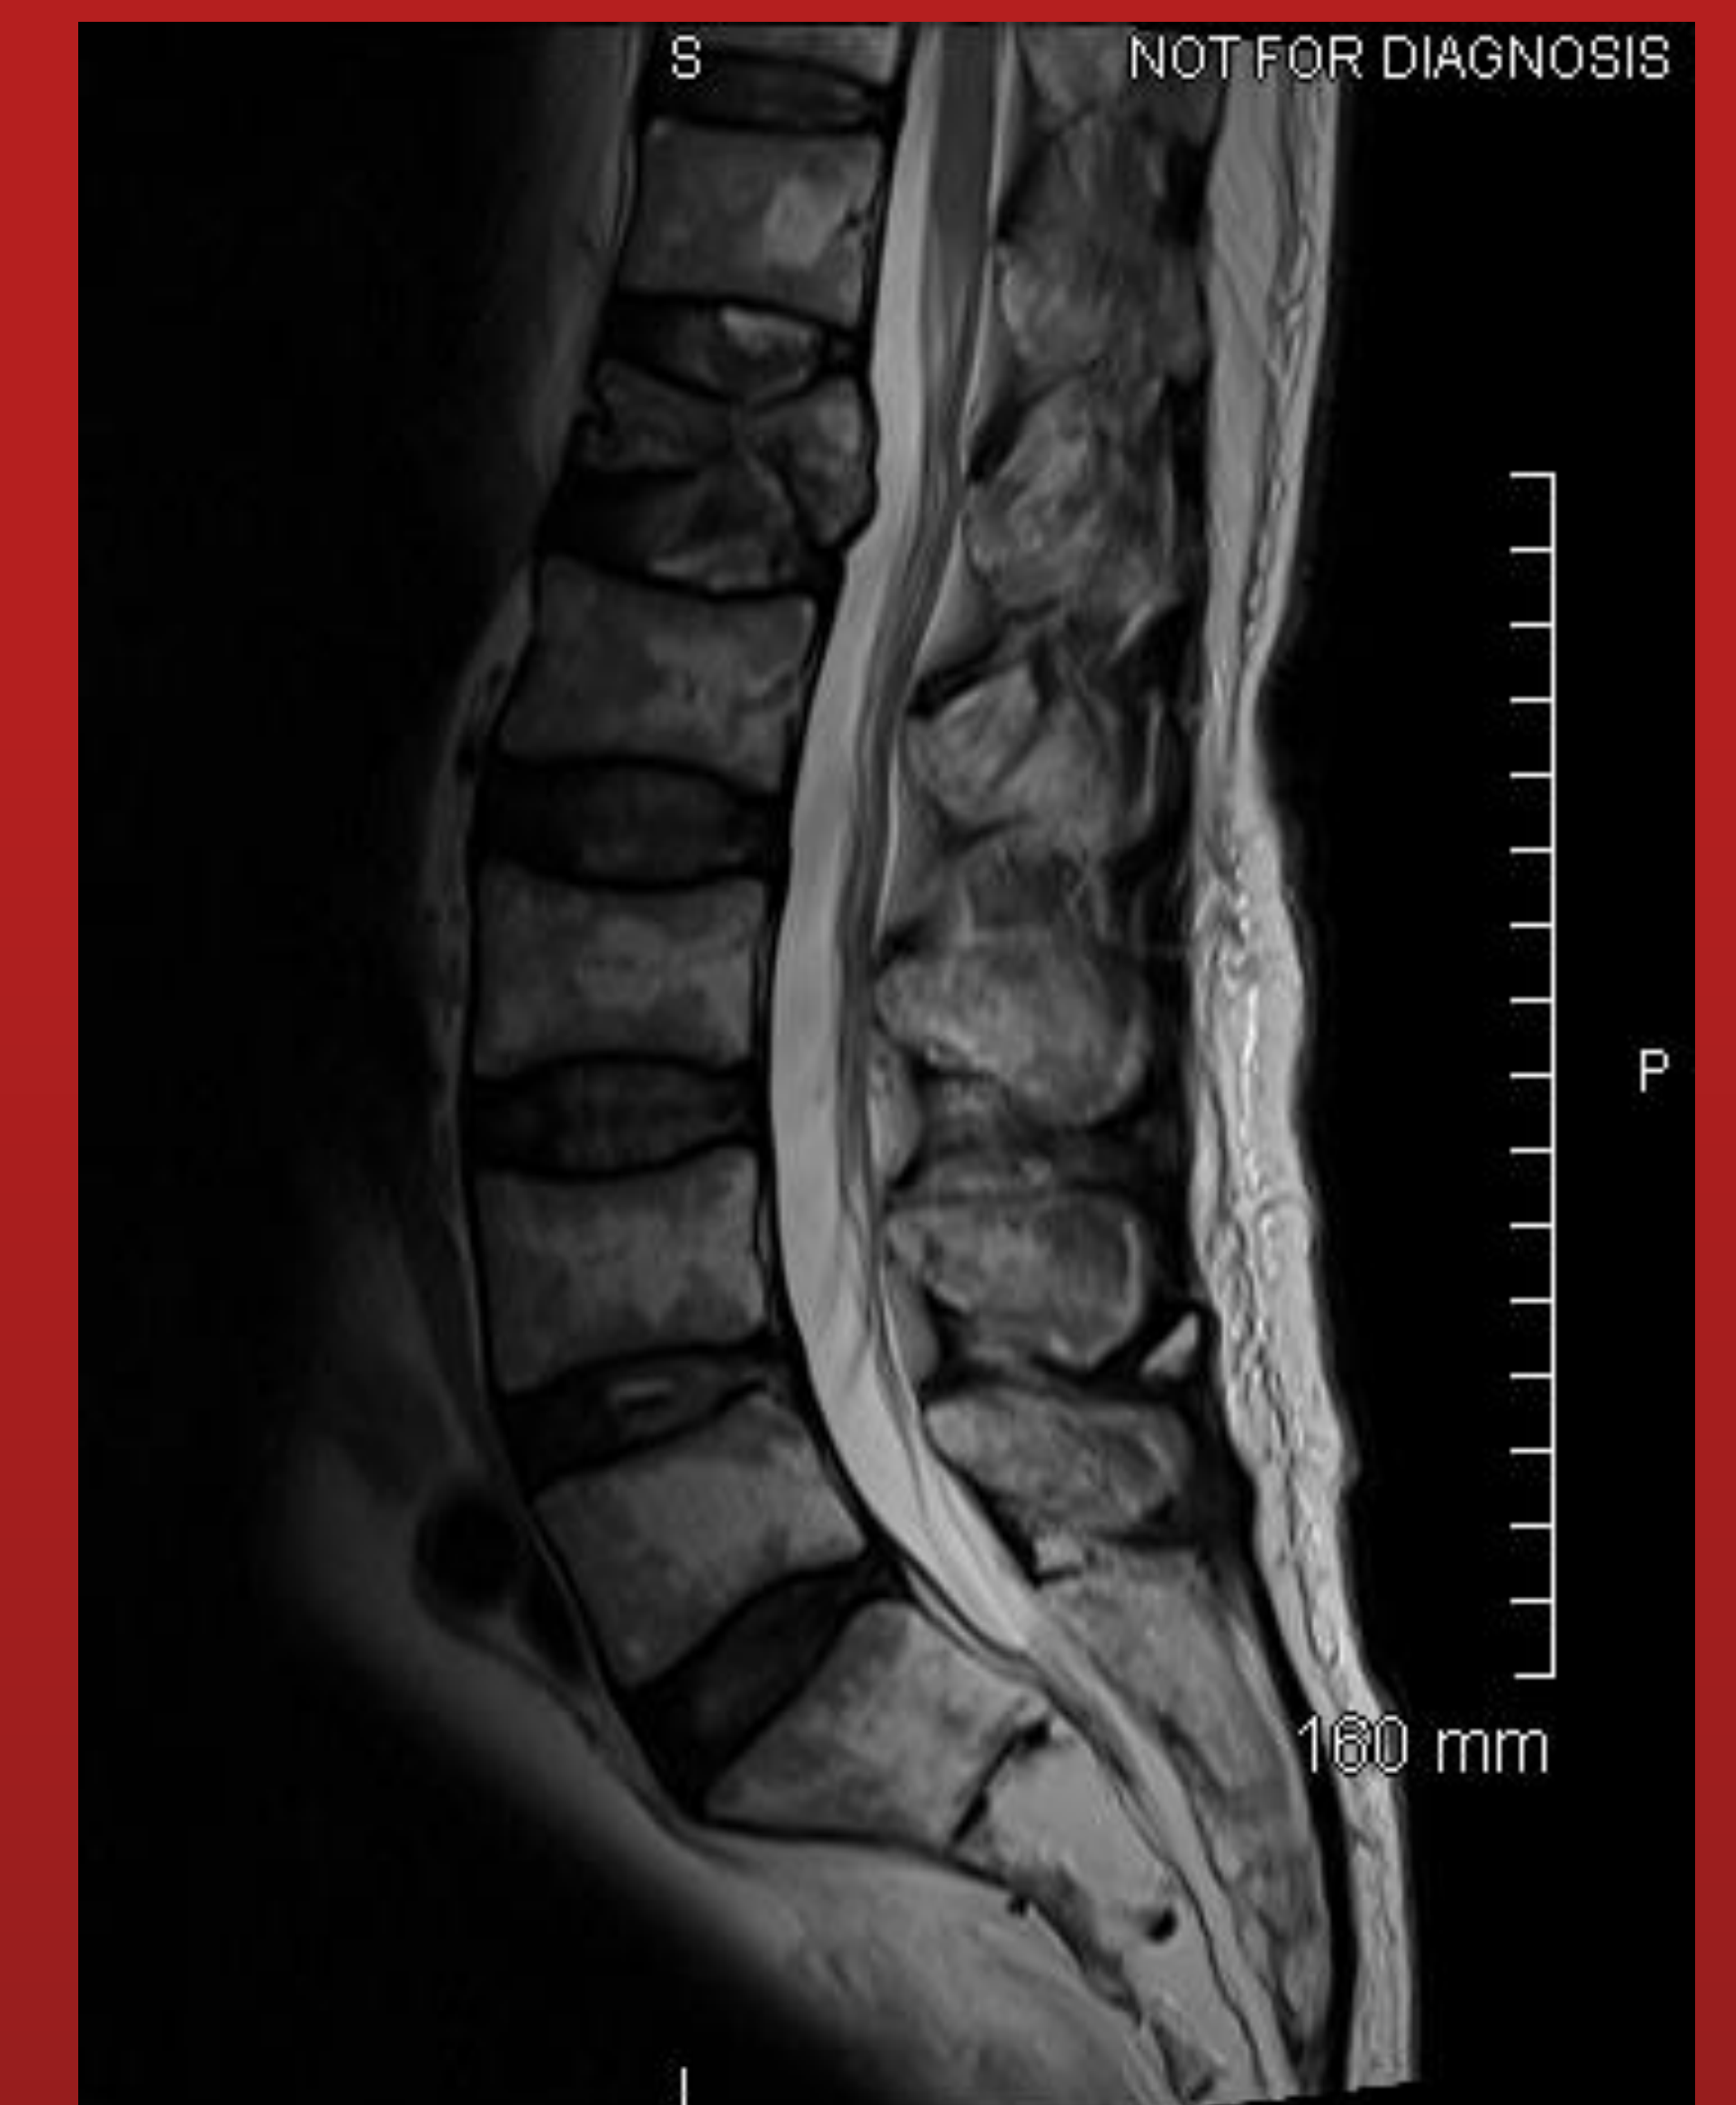
Figure 3. Sagittal MRI image demonstrating a compression fracture at L1. Retropulsion of L1 4mm into the spinal canal is exhibited. Retrieved from facility PACS system.

Magnetic resonance (MR) is another modality that can provide more information about the extent of a compression fracture because of its ability to critically evaluate the spinal cord and other soft tissue anatomy like the vertebral disks (see figure 3). Compression fractures can be associated with a herniated nucleus pulposus, "slipped disk", and can potentially cause compression of the spinal cord leading to severe neurological deficits. (Colangelo, 2014; Dewar, 2015; Odle, 2017).
